June 28, 2019
File No. 262018.063

Subject: Department of Natural Resources Washington Geological Survey,
School Seismic Safety Assessment Project, Contract No. AE 410 -
Seismic Evaluation for **Battle Ground School District**

School Buildings Evaluated in the Battle Ground School District

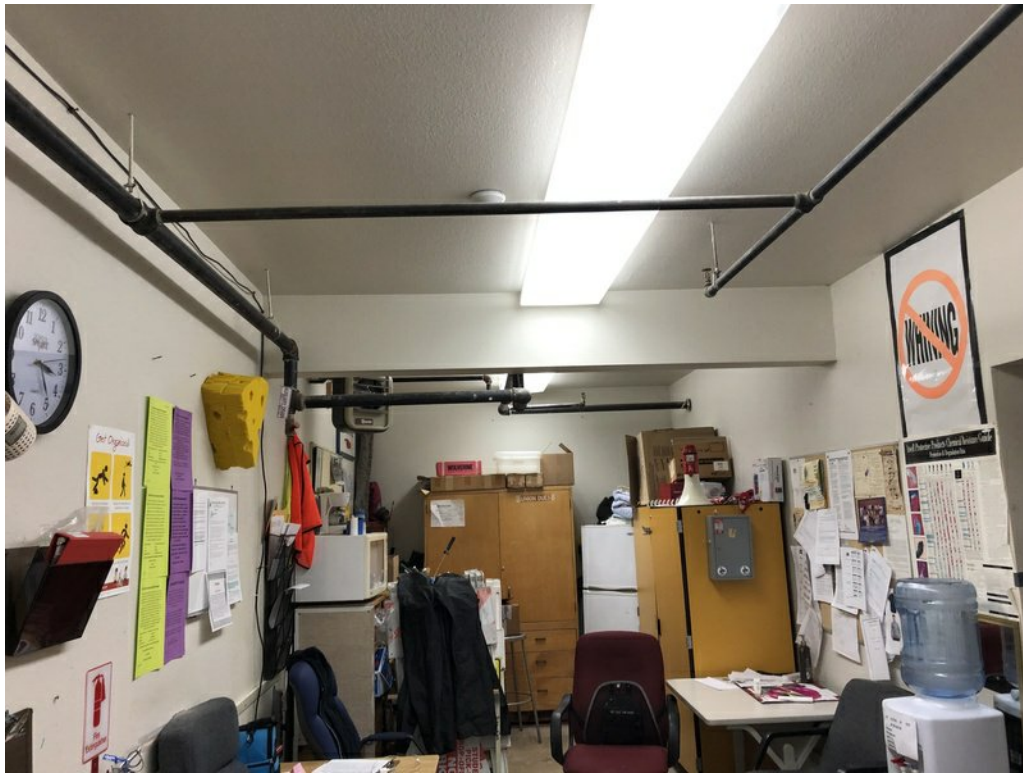
Figure 1-5. Unbraced Fire Sprinkler Piping

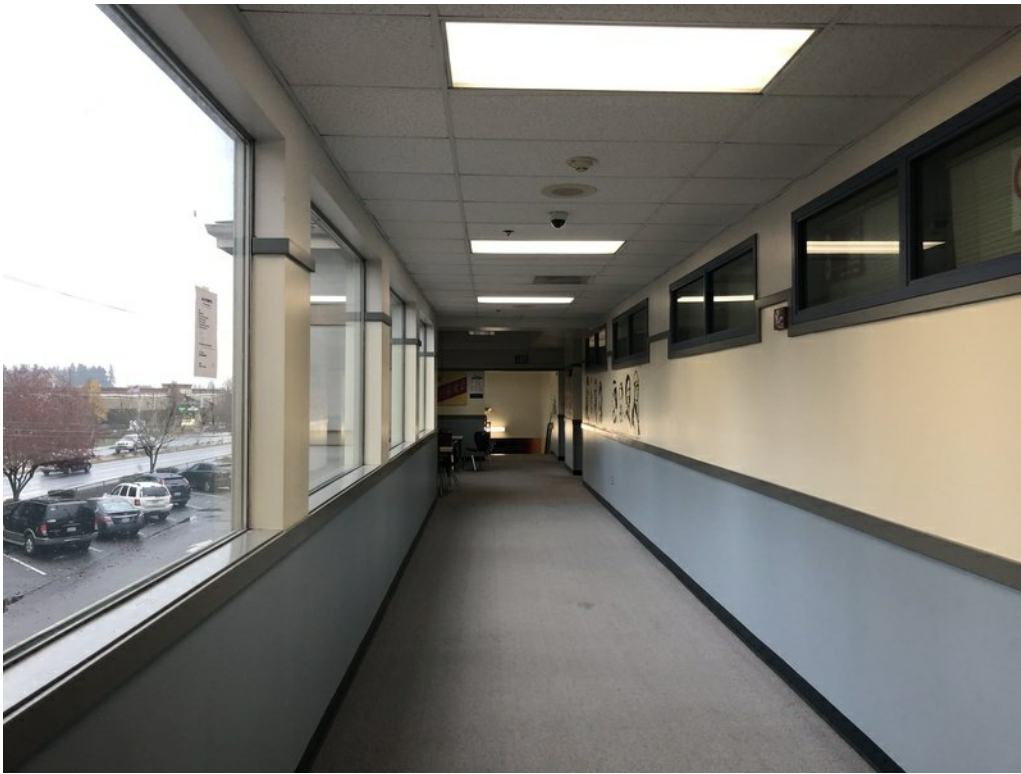
Figure 1-4. Large Exterior Glazing Panes in Hallway

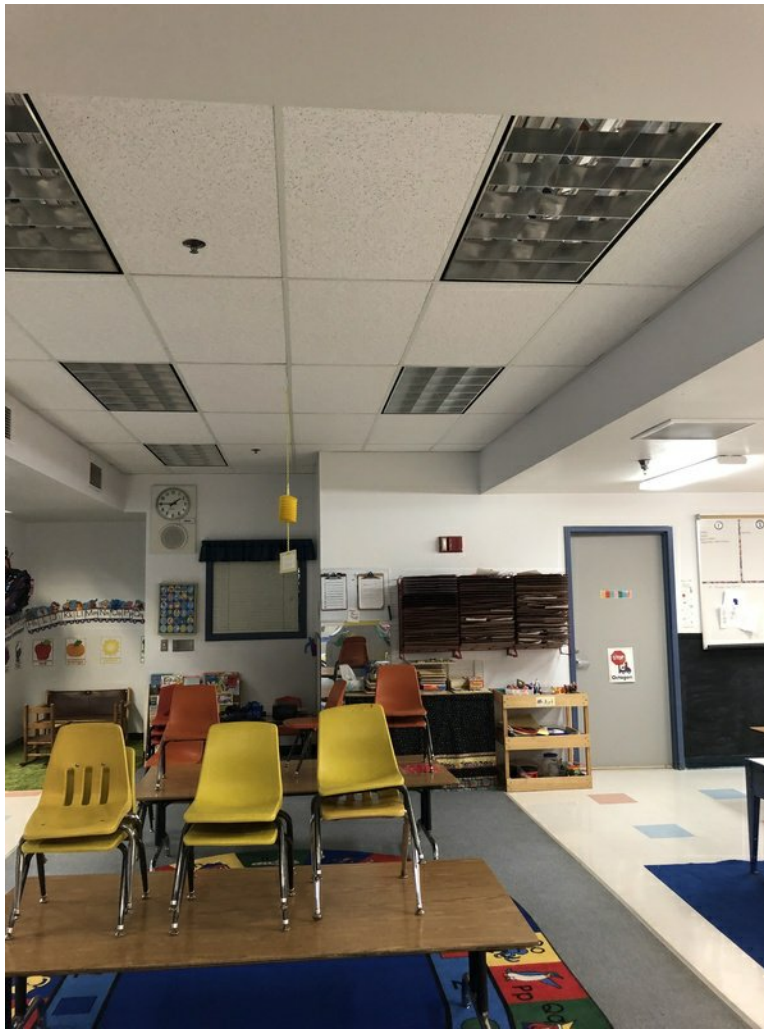
Figure 1-5. Inadequate Fire Sprinkler Penetration Clearance in Classroom, Typical Throughout

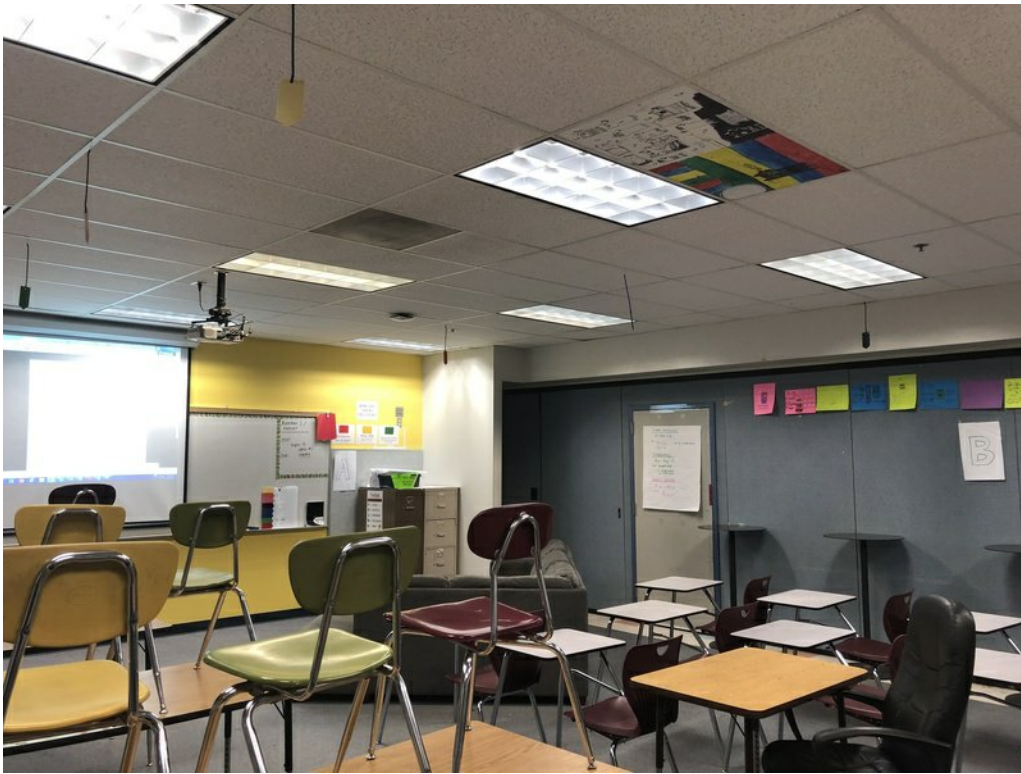
Figure 1-6. Typical Classroom. Seismic Bracing of Light Fixtures is Unknown.

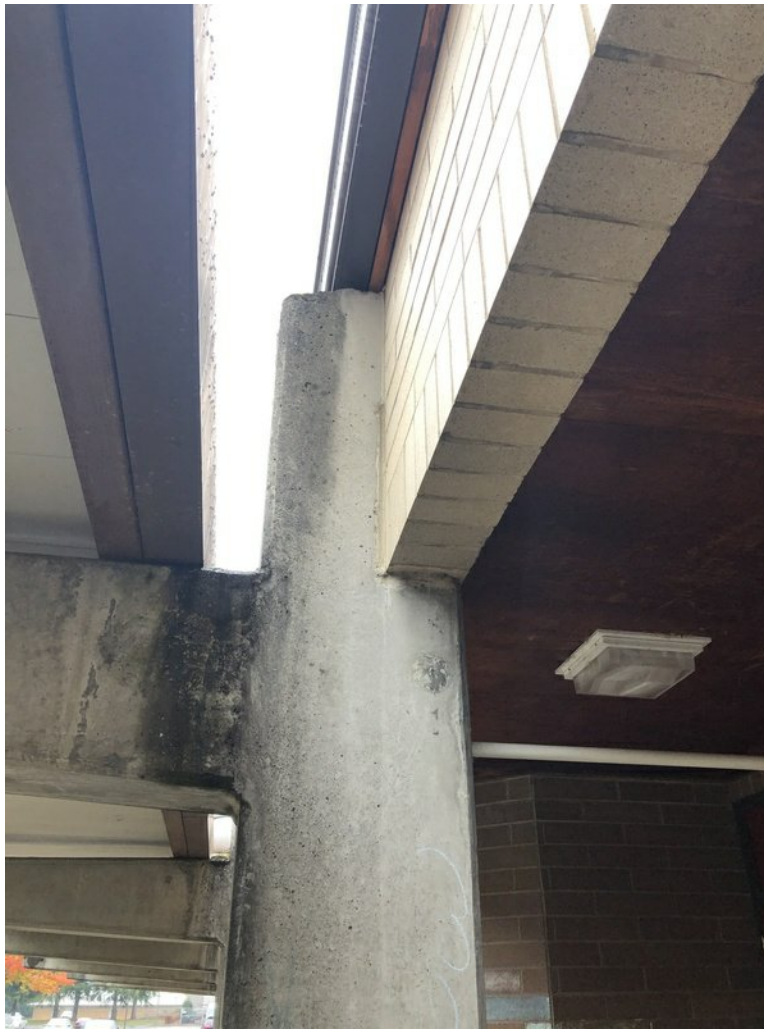
Figure 1-5. Masonry over Precast Column at Exterior As-Built Condition Versus Precast Concrete Beam in Drawings

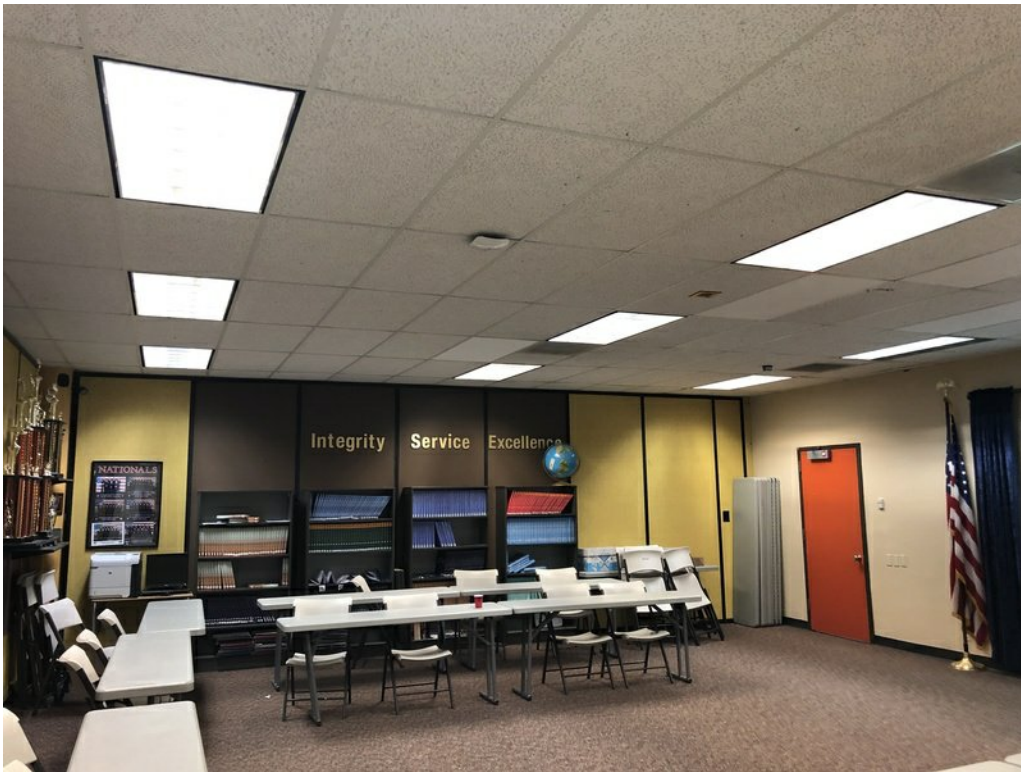
Figure 1-7. Typical Classroom with Unknown Light Fixture Bracing

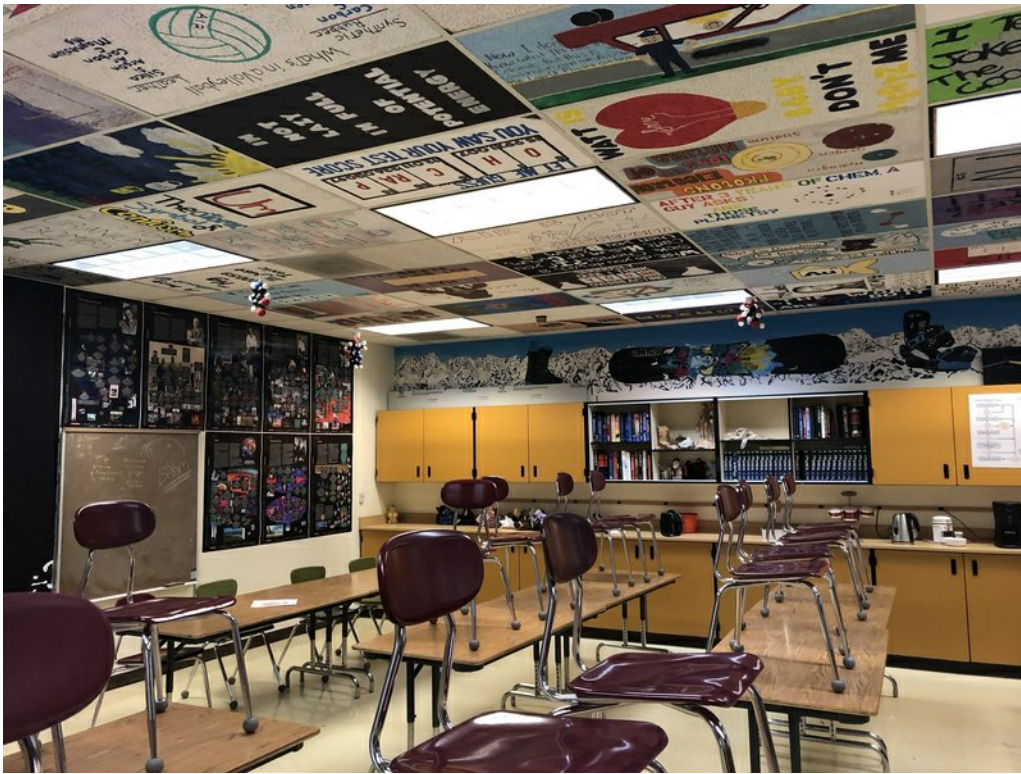
Figure 1-5. Science Classroom with Unknown Light Fixture Bracing

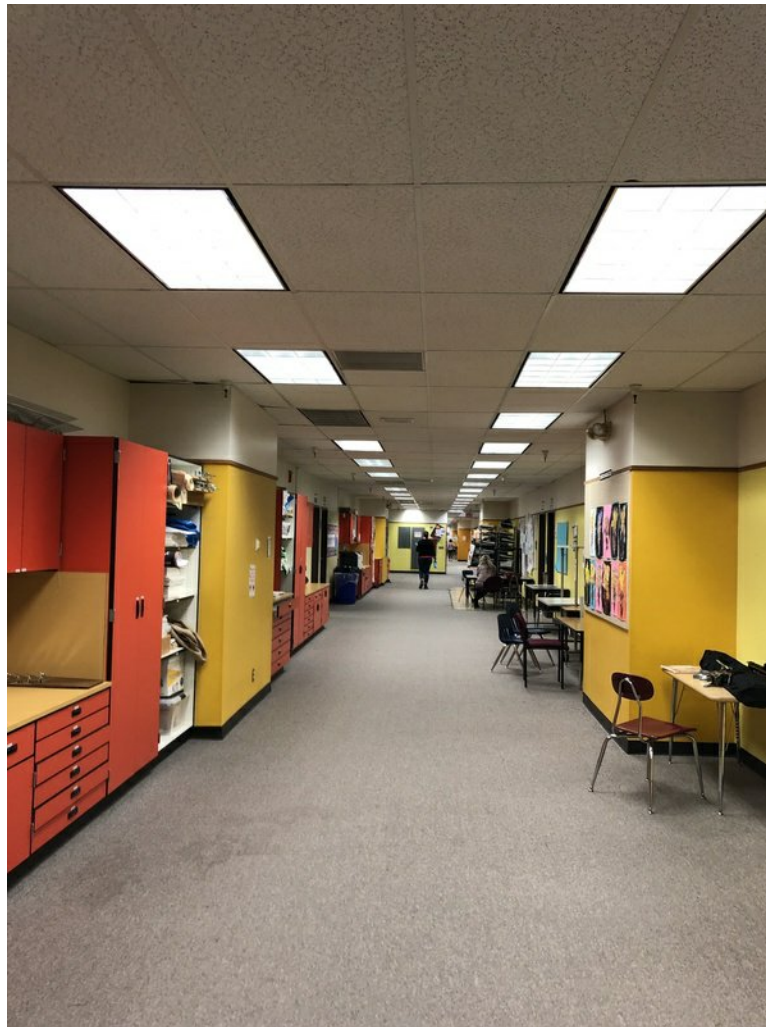
Figure 1-4. Inadequate Fire Sprinkler Penetration Clearance, Typical Throughout

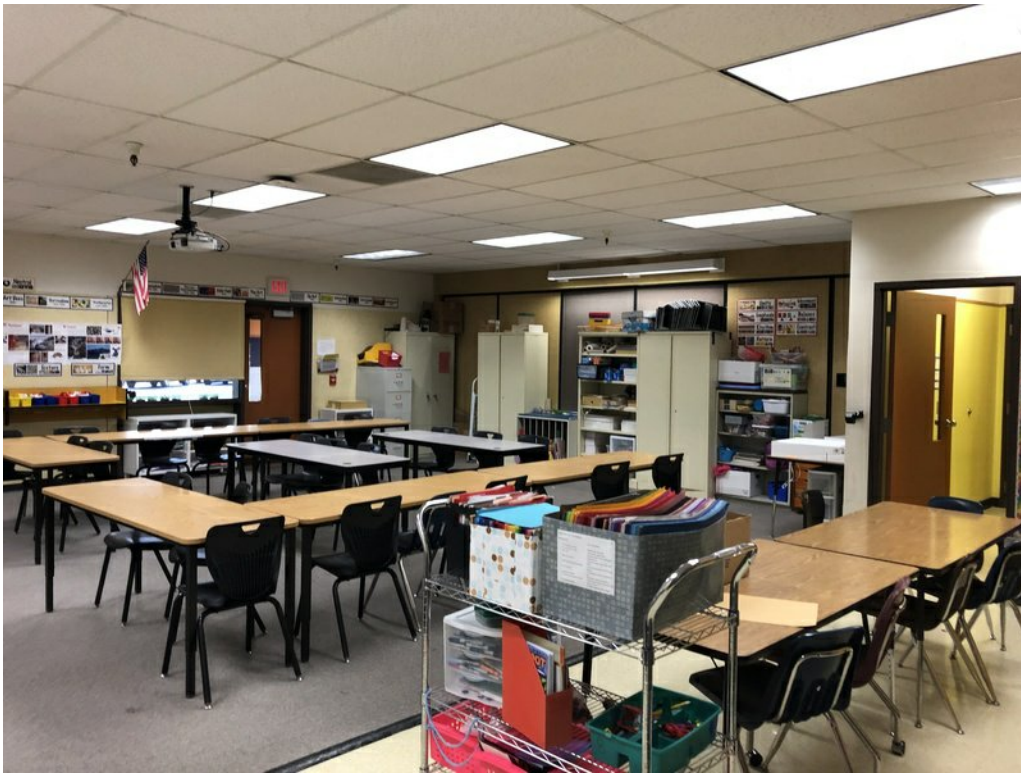
Figure 1-5. Classroom with Unbraced Tall Narrow Contents, Typical

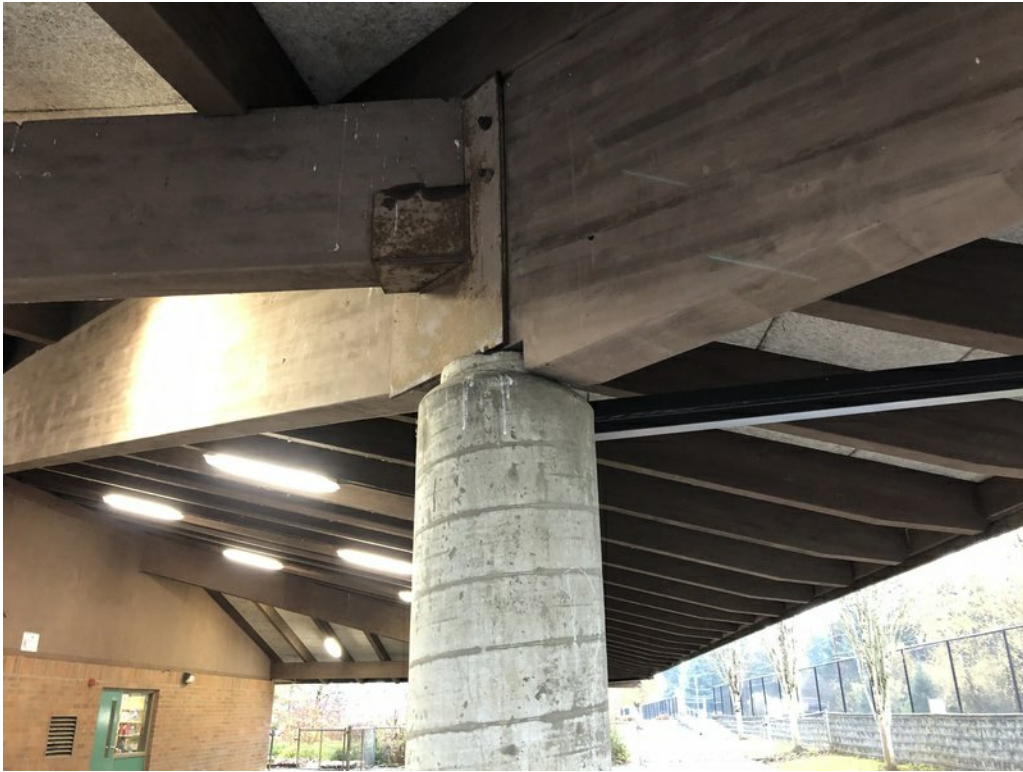
Figure 1-10. Girder to Concrete Column Connection. Unknown Detailing.
